# GreyStone Inspection Report Sample

**9 Dream Lane  
Jekyll Island, GA 31527**

Inspected By: **Ted Rodgers**  
*Certified Residential Home Inspector #5212980-R5*

July 9, 2006

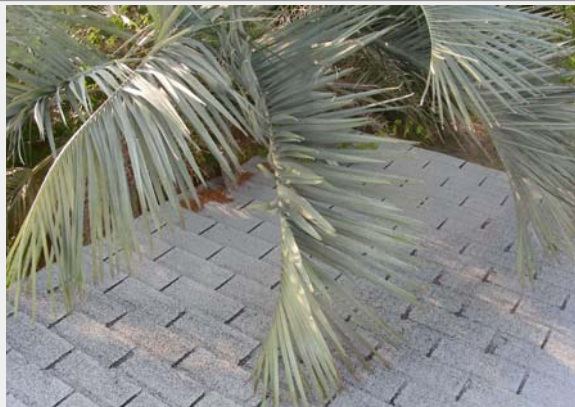
**Trees Contacting Roof**

- Landscaping needs attention. It has been neglected.
- One or more **trees are in contact with the roof or structure**. They should be trimmed to eliminate the possibility of damage. Palm trees are in contact with the roof at the back center, the back right corner and the front left corner.

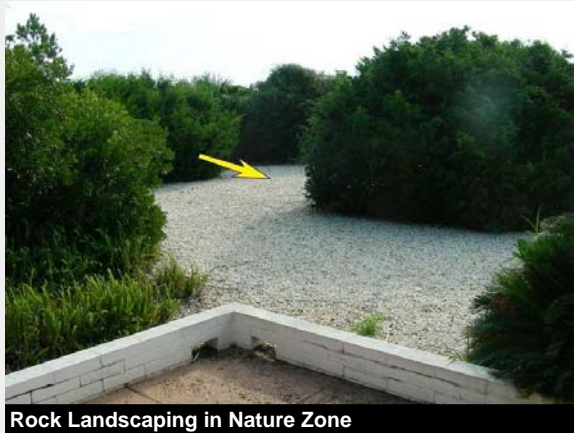
**Rock Landscaping in Nature Zone**

- Noted that the low maintenance rock landscaping in the back yard was **extended well past (at least 30' to 40')** the prohibited nature zone that was set by the Jekyll Island Authority. Recommend checking with the Jekyll Island Authority for information on any requirements that pertain to landscaping in the prohibited zone.

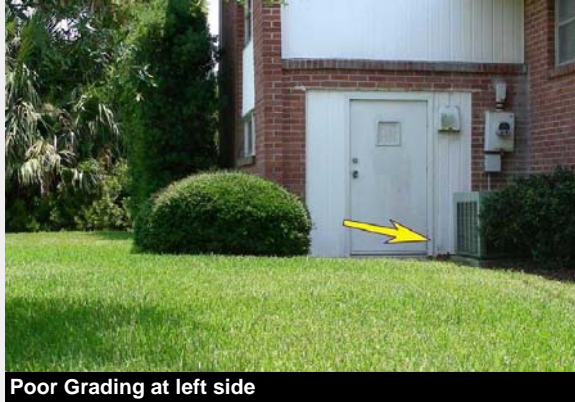
**Poor Grading at left side**

The **grading at the foundation needs improvement** in one or more areas. The soil should be pitched away from the foundation a minimum of 6" in the first 10 feet.

- Improvements are needed at the **left side in front of the basement door**. That corner appears to be flat or slope toward the foundation.

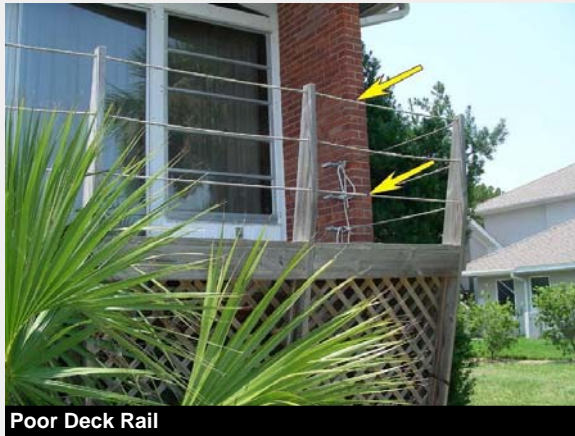
**Poor Deck Rail**

- The **deck guard rail is climbable** in several locations. This is a safety hazard for small children who can climb the rail and fall off the deck.
- The **rail spacing exceeds the 4 inch maximum**. This can potentially allow a small child to fall

- through and is considered a safety hazard.  
The deck or **deck surface is weathered and porous**. Recommend sealing or painting to protect from further deterioration.

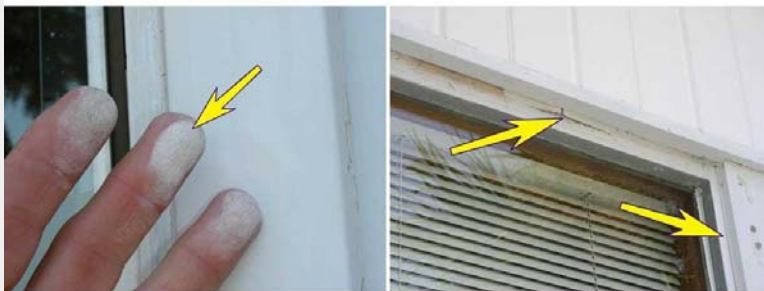
**Worn Trim Paint / Sealing Needed at Joints**

- **The trim needs painting.** Painted finish is very oxidized.
- The wood trim around the windows is clad in metal. **Some of the joints are not sealed.** This can allow water to enter under the metal, causing moisture damage. Recommend sealing all joints in the trim.  
Additionally, the condition of the wood under the metal **cannot be evaluated.**

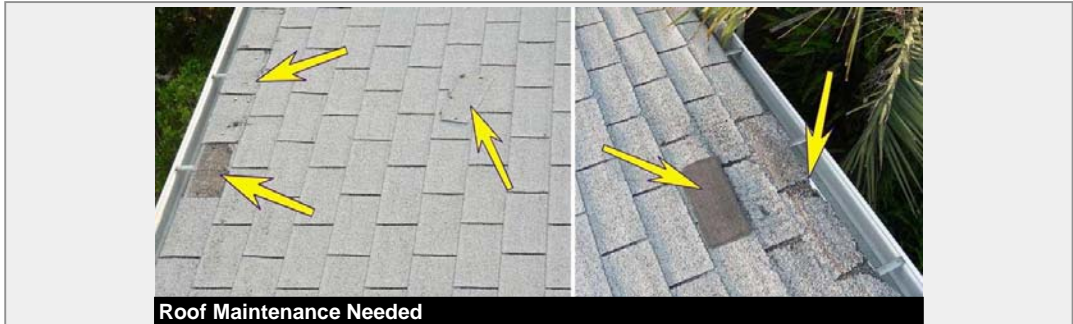
- Minor **cupping and curling was noted**. This is an indication of advancing age.
- It appears the **roof has two or more layers of shingles**. While this is allowed by most building authorities, it is never a good idea because it significantly shortens the life of the new roof. In addition, the **cost of removing** two layers of roofing is much higher than a single layer.
- Noted some **damaged and missing shingles** over the north side hallway and at the rear over the kitchen. Minor roof maintenance is needed.

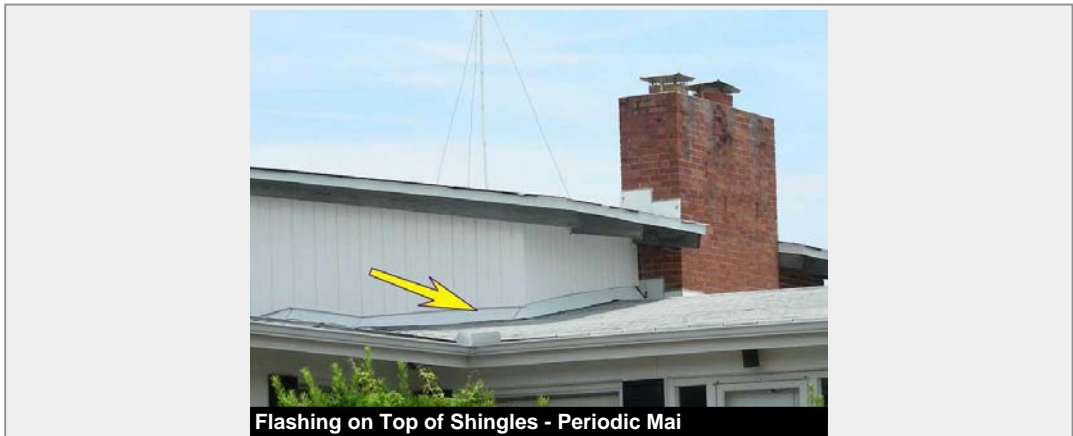
Roof flashings are **externally installed** and will need periodic maintenance. *Flashings properly installed will be under the siding and the roofing.*

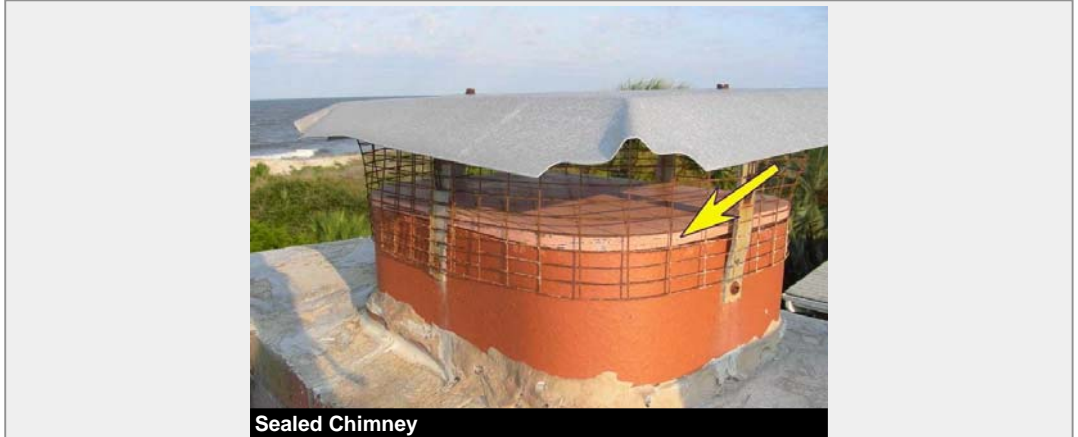
**Sealed Chimney**

- Both flues are sealed at the caps. Chimney caps appear in good condition.

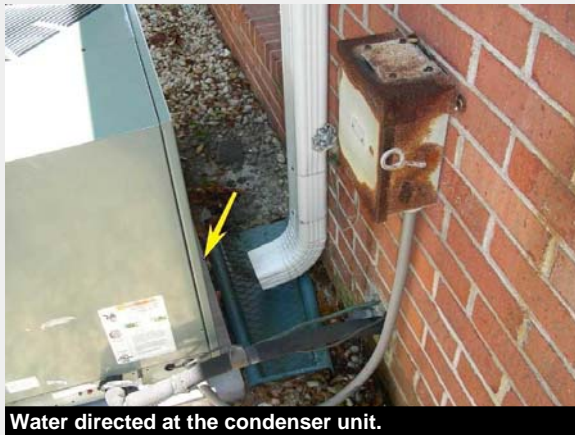
- It is recommended that a **diverter tube be added** to carry the roof run off well away from the structure at all downspouts. The downspout at the right front corner **umps water directly toward the condenser.**

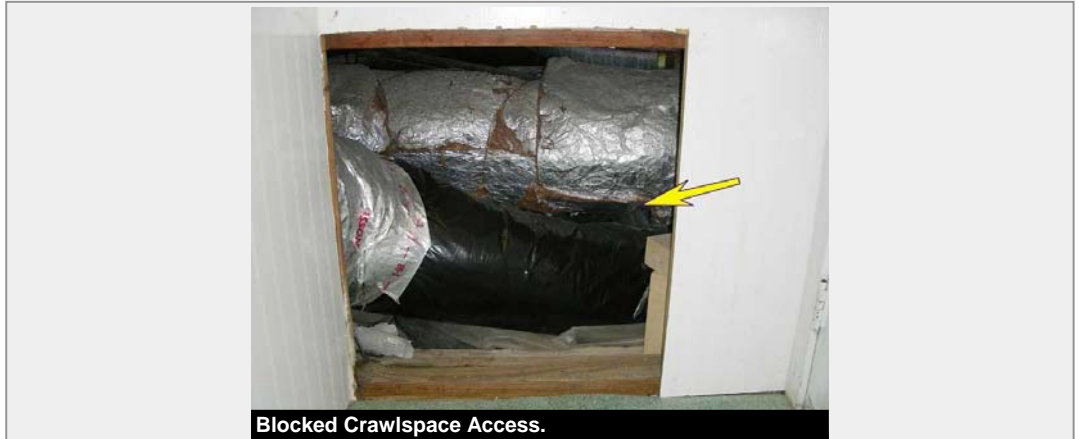
**Blocked Crawlspace Access.**

- The original crawlspace entry was completely blocked by added HVAC ductwork. I was able to enlarge another hole located next to the basement bathroom to gain access, however, **the main portion of the crawlspace under the south side of the structure is virtually inaccessible**. I did manage to squeeze through a small opening to view it, but no repairs could be made with the current access. Recommend **cutting a new access door to the crawlspace from the rear exterior**. There are repairs and upgrades that need to be done and access to the crawlspace is needed. The access opening for the north side crawlspace is also too small and **should be enlarged for easy access**. (*Abandoned ductwork at this entry is also blocking access*).

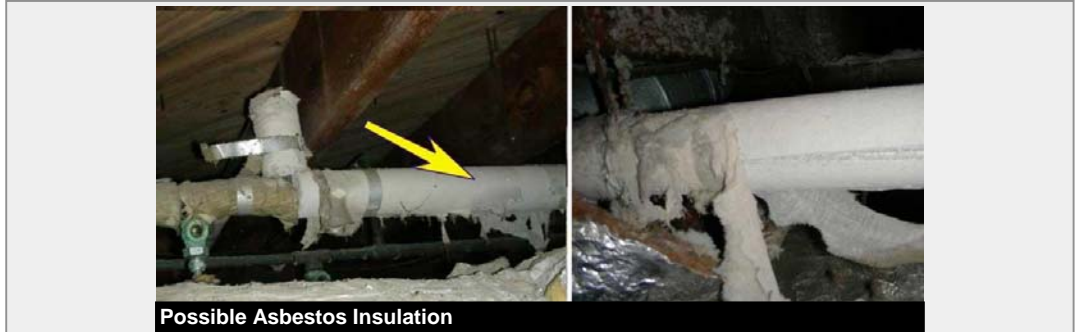
**Possible Asbestos Insulation**

- Noted an **insulating pipe wrap material that may be made of asbestos**. Took a sample to send to a lab for testing. If material is asbestos, there are two options. 1) Have all asbestos insulation removed (\$\$\$) or 2) Have asbestos material encapsulated by wrapping in tape and sealing with liquid mastic (a duct sealant).

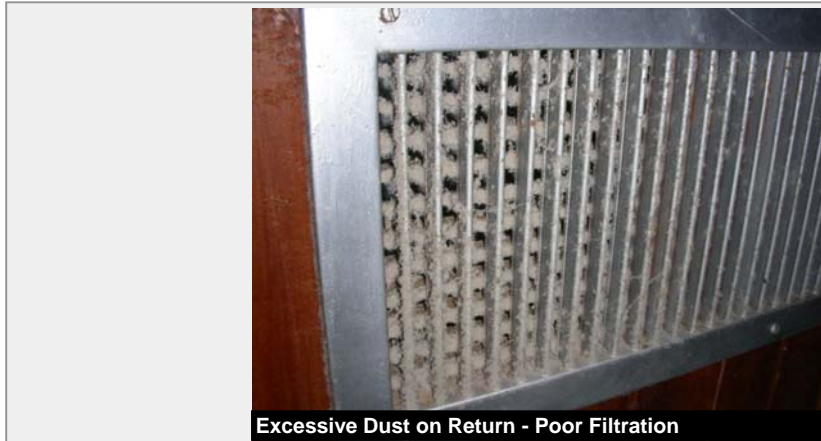
**Excessive Dust on Return - Poor Filtration**

- The air filter is the thin metal mesh filter that is supplied from the manufacturer. **The weave of the filter is too coarse and does a poor job of filtering.** This is indicated by the excessive amount of dust that has collected on the return vent in the master bedroom. Recommend contacting licensed HVAC technician to service unit. Since unfiltered air has been circulating through the system the **A-Coil should also be cleaned.** *This cleaning is not part of a normal service and cleaning and must be specifically requested.*

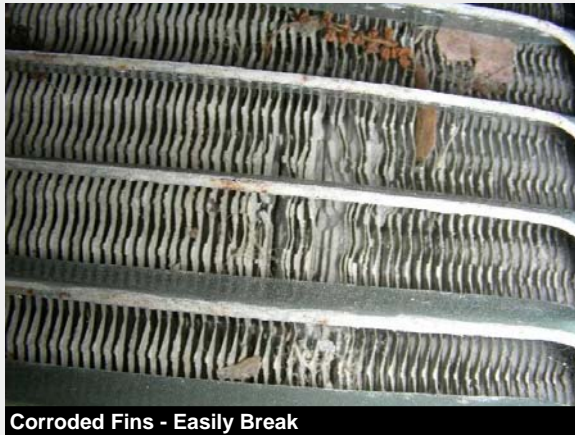
**Corroded Fins - Easily Break**

- The **cooling fins on this condenser are heavily corroded**. They easily break when touched. Cooling efficiency may be adversely affected by the corrosion. This unit is not protected from a direct sea breeze and the salt appears to have affected the fins. **Unit will need to be replaced within a short time.**

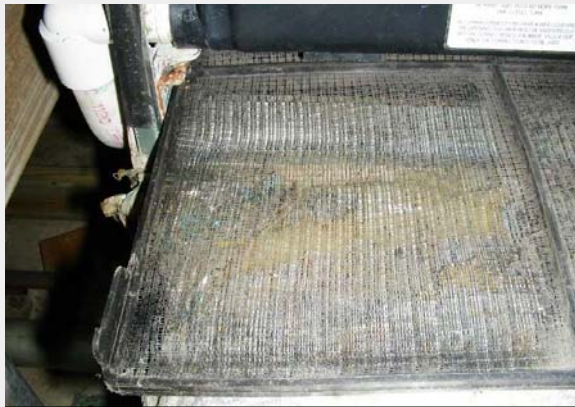
**Thin ineffective Air Filter**

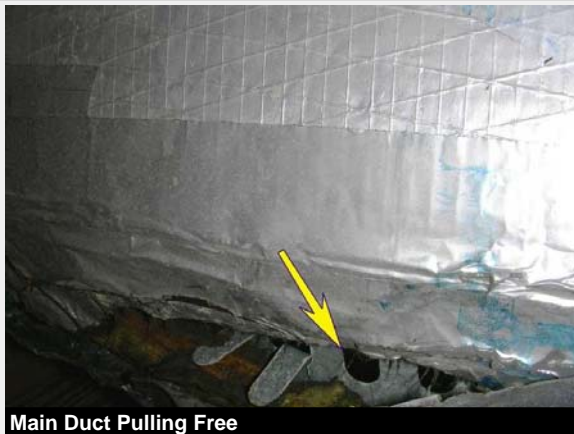
Main Duct Pulling Free

- Numerous **leaks were detected** around the plenum or return. One of the main supply ducts in the basement utility room is **pulling loose and a significant amount of conditioned air is being lost**.

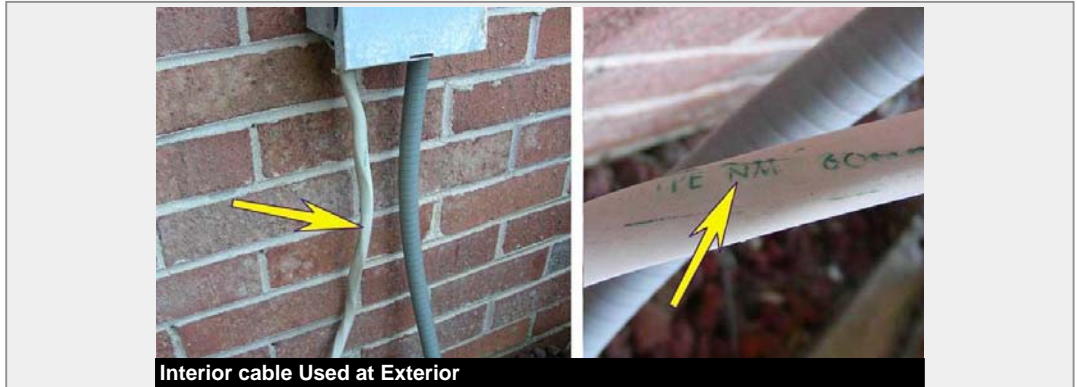
Interior cable Used at Exterior

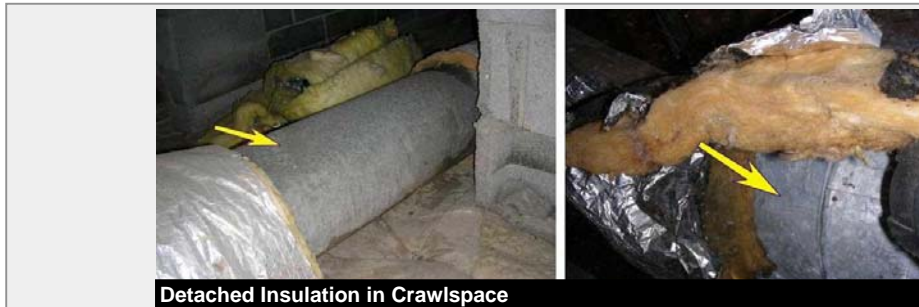
Detached Insulation in Crawlspace

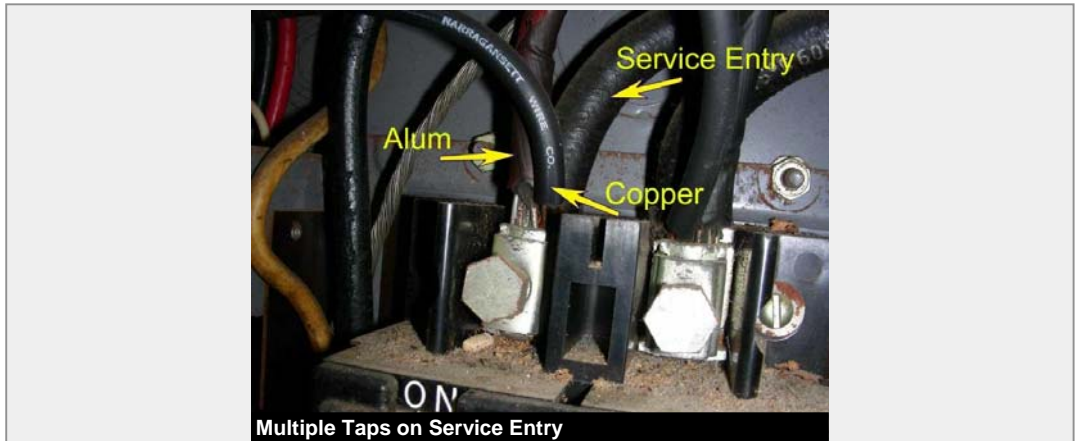
- There are two additional circuits that are **tapped directly to the service feed**. This is not an approved electrical connection. **There should be no other circuits tapped directly to the service conductor feed**. In addition, one of the conductors tapped to the aluminum service feed is a copper conductor. **Copper and aluminum should not be in direct contact with one another**. Recommend repair by a licensed electrician.
- The electrical panel is **old and outdated**. Replacement should be considered.
- There is **inadequate clearance around the electric panel**. Current codes require a 36" working space in front of panels and 30" across.

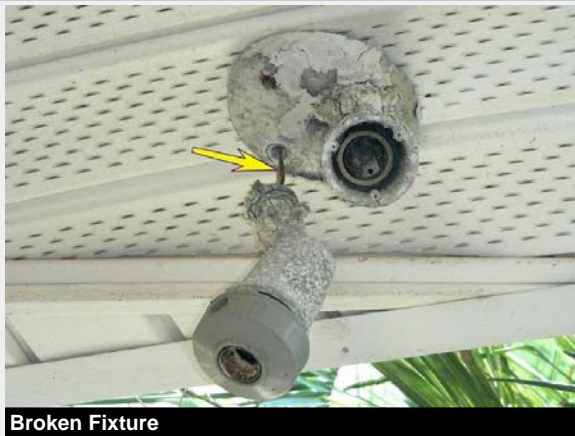
- The flood light fixture at the right rear corner is broken and is dangling from its electrical wiring. Recommend replacement.

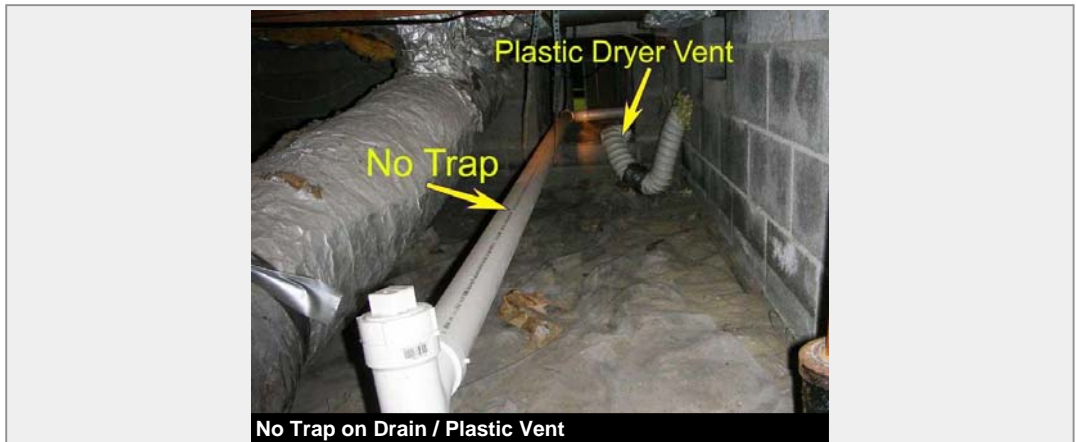
- A plastic dryer vent is installed from the laundry and into the wall. It is against current fire safety codes to penetrate walls with anything except smooth metal venting for dryers. **Plastic material is a potential fire hazard if used in any position for dryer vents.** Recommend replacing dryer vent from laundry room to exterior with smooth metal vent.
- The **laundry drain was installed without a trap.** Sewer gases can escape into the living spaces without a trap. Recommend installation of a trap on the laundry drain.

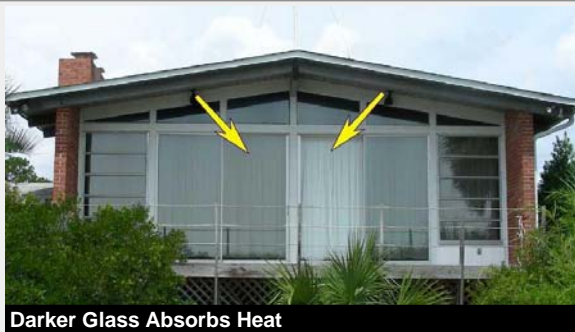
- Noted that the glass in some windows and in the living room sliding doors (all but one door) has a darker tint. This tinted glass absorbs heat from sunlight and radiates it into the room.

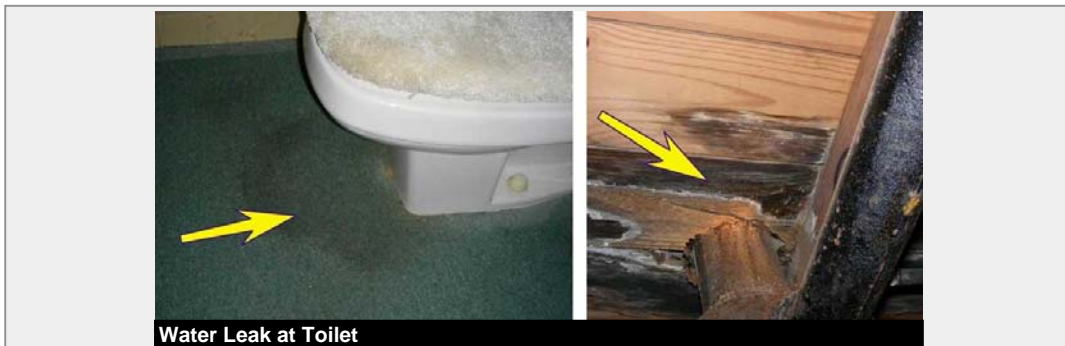
- The **toilet appears to be leaking** at the wax seal. Noted water stained carpet and water stained sub flooring in the crawl space. Recommend replacing the wax seal.
